Manhole Inspection Summary

Manhole # S25I__021MH

Insp Date: **4/1/09 6:58 AM**

Location Address: **103 Mt Clare**

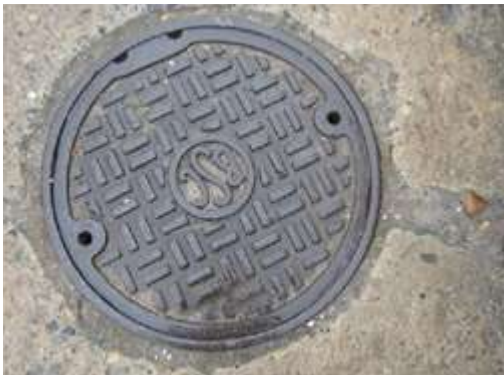
Miscellaneous

mh cover

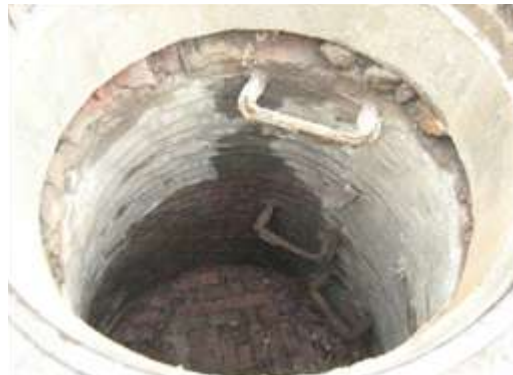
Defect 4

Condition: ☐ Sound ☐ Cracked ☐ Root Intrusion ☐ Loose Brick ☒ **Deteriorated**

Infiltration: ☐ None ☒ **Joint** ☐ Cracks ☒ **Mortar** ☐ Roots ☐ Wall

Infiltration: ☐ None ☐ Joint ☐ Cracks ☐ Mortar ☐ Roots ☒ **Wall**

Steps Count: **4** Missing: **1** ☒ **Corroded**

deteriorated chimney; chimney infiltration and infiltration at corbel; missing/corroded rungs

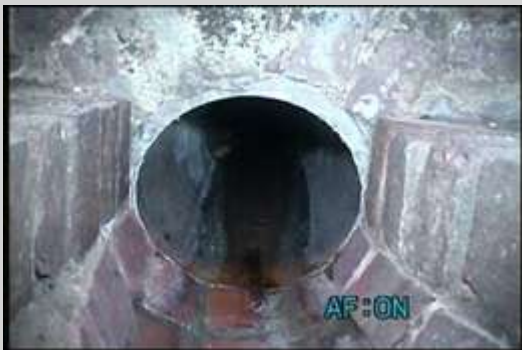
12 O'Clock Outflow

Pipe Height: **8.4** (in.) Rod and Bar (Angled)
Pipe Material: **Clay** ☐ Pipe Lined
Invert Depth: **7.52** (ft.) Flow Characteristics: **Slow**
Deposits: ☒ None ☐ Mud ☐ Sludge ☐ Debris ☐ Grease
Silt Depth: **0** (in.) Deposits Extent:
Infiltration: **None** Pipe Seal Cond: **Sound**

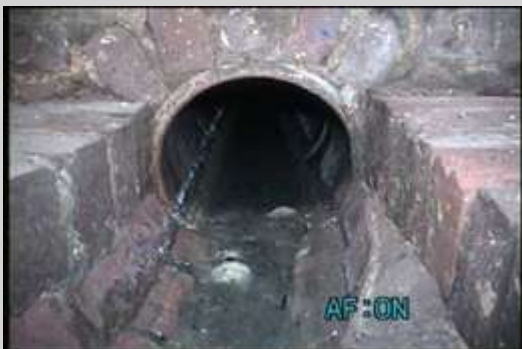
3 O'Clock Inflow

Pipe Height: **8.4** (in.) Rod and Bar (Angled)
Pipe Material: **Clay** ☐ Pipe Lined
Invert Depth: **7.49** (ft.) Flow Characteristics: **Slow**
Deposits: ☒ None ☐ Mud ☐ Sludge ☐ Debris ☐ Grease
Silt Depth: **0** (in.) Deposits Extent:
Infiltration: **None** Pipe Seal Cond: **Sound**
